RESEARCH MEMORANDUM

DITCHING INVESTIGATION OF A 1/12-SCALE MODEL
OF THE DOUGLAS F4D-1 AIRPLANE

TED NO. NACA DE 384

By John O. Windham

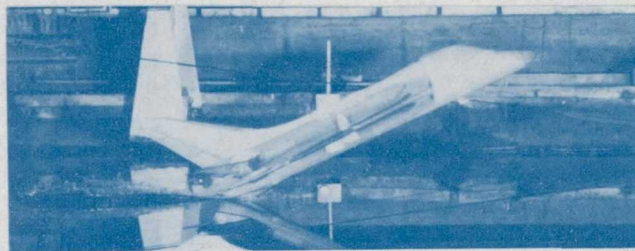
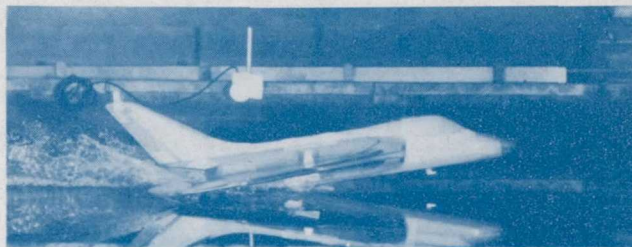
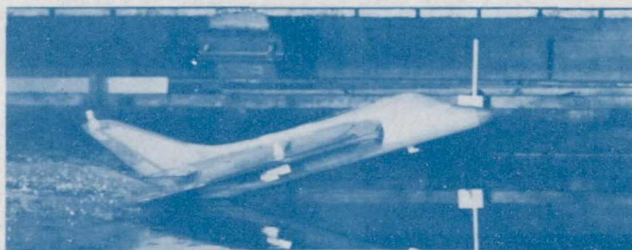
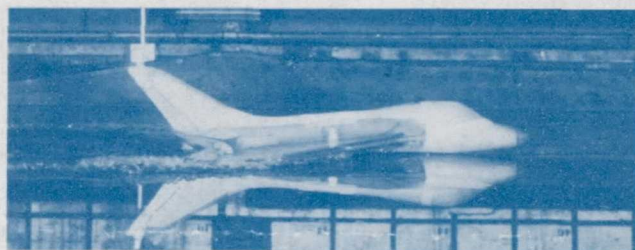
(a) No damage simulated.

The Douglas F4D-1 airplane lands at a very high attitude, and consequently the aft fuselage and trailing edge of the wing made first contact with the water (fig. 6). At the 22° landing attitude, the undamaged model with landing gear retracted trimmed down immediately after contact and then trimmed up and ran smoothly. At the 18° and 14° attitudes, the model trimmed down at contact and then trimmed up, skipped

once or twice, and then ran smoothly. The lengths of landing runs for the undamaged model varied from 600 to 770 feet. Maximum longitudinal decelerations of 1g to 2g and maximum normal accelerations of $3\frac{1}{2}$ g to $6\frac{1}{2}$ g were recorded for the three attitudes (table I and figs. 6(a) and 7(a)). The delta-shaped wing, with the control surfaces (elevons and trimmers) necessitated by this configuration, had no detrimental effect on behavior. The wing-root jet inlets had little effect on behavior of the undamaged model since they did not enter the water until the low-speed part of the landing runs.

In general, the effect of landing attitude on behavior depended on the speeds associated with that attitude. The lower attitudes with the accompanying higher speeds resulted in motions more violent and undesirable than those of the higher attitudes and lower speeds. Consequently, a ditching should be made at the lowest speed and highest attitude (near 22°) consistent with adequate control.

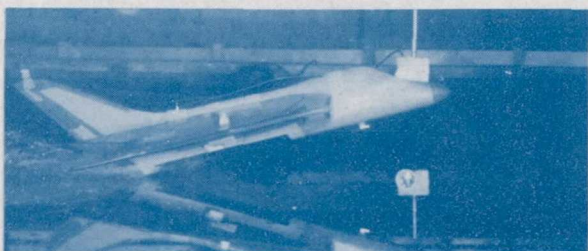
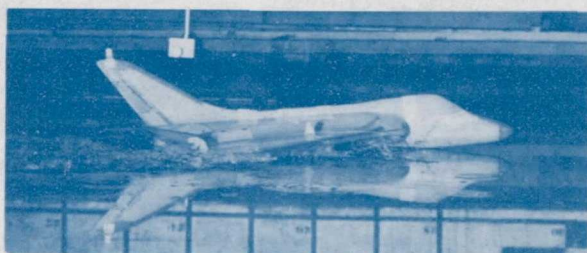
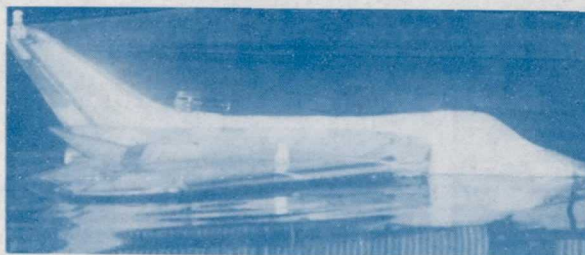
(b) Aluminum-covered frame installed.

When the aft portion of the fuselage bottom was replaced with rigid frames covered with aluminum foil, appreciable damage resulted (fig. 8). The model nosed in or dived, the accelerations were higher, and the runs were shorter than for the undamaged condition. Maximum longitudinal decelerations of about 4g to 8g and maximum normal accelerations of 4g to 6g were encountered in landing runs of about 340 to 420 feet (table I and figs. 6(b) and 7(b)). The damage permitted rapid flooding which made a short flotation time probable for the airplane. When fuselage damage occurred, the wing-root jet inlets entered the water during the high-speed part of the run and added to the drag of the model especially at the higher landing speeds.

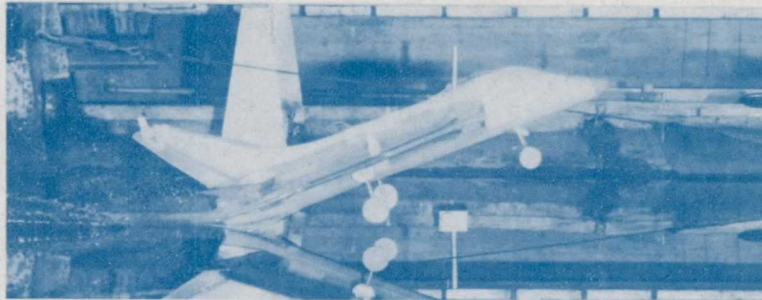
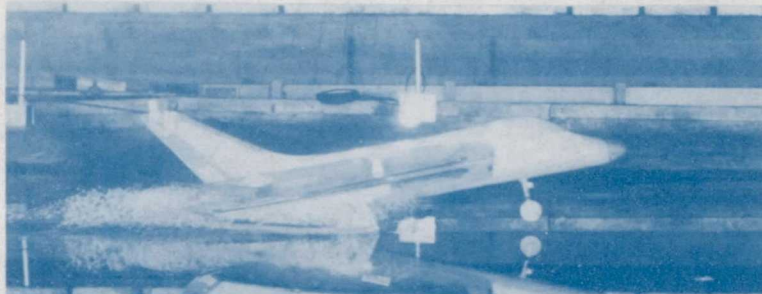
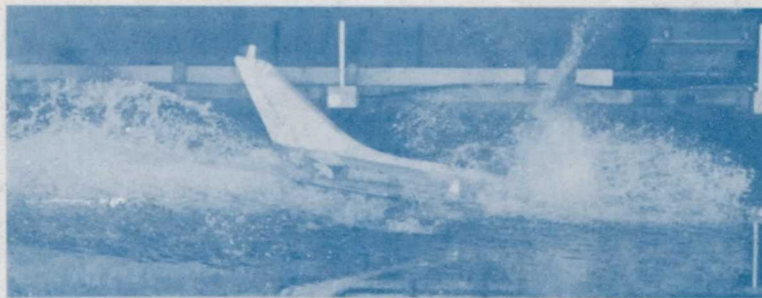
(c) Scale-strength landing gear installed. L-93547

In landing runs with the landing gear extended and attached at scale strength, the landing gear did not fail. The model either dived abruptly or flipped over. At the 22° attitude, the model dived; maximum longitudinal decelerations of about $5\frac{1}{2}$ g and maximum normal accelerations of about $3\frac{1}{2}$ g were encountered in a landing run of about 170 feet (table I and figs. 6(c) and 7(c)). In landings at the other attitudes, the model flipped over and the accelerations generally exceeded the 10g maximum longitudinal and the 6g maximum normal ranges of the accelerometer. Thus a ditching should always be made with landing gear retracted if possible.

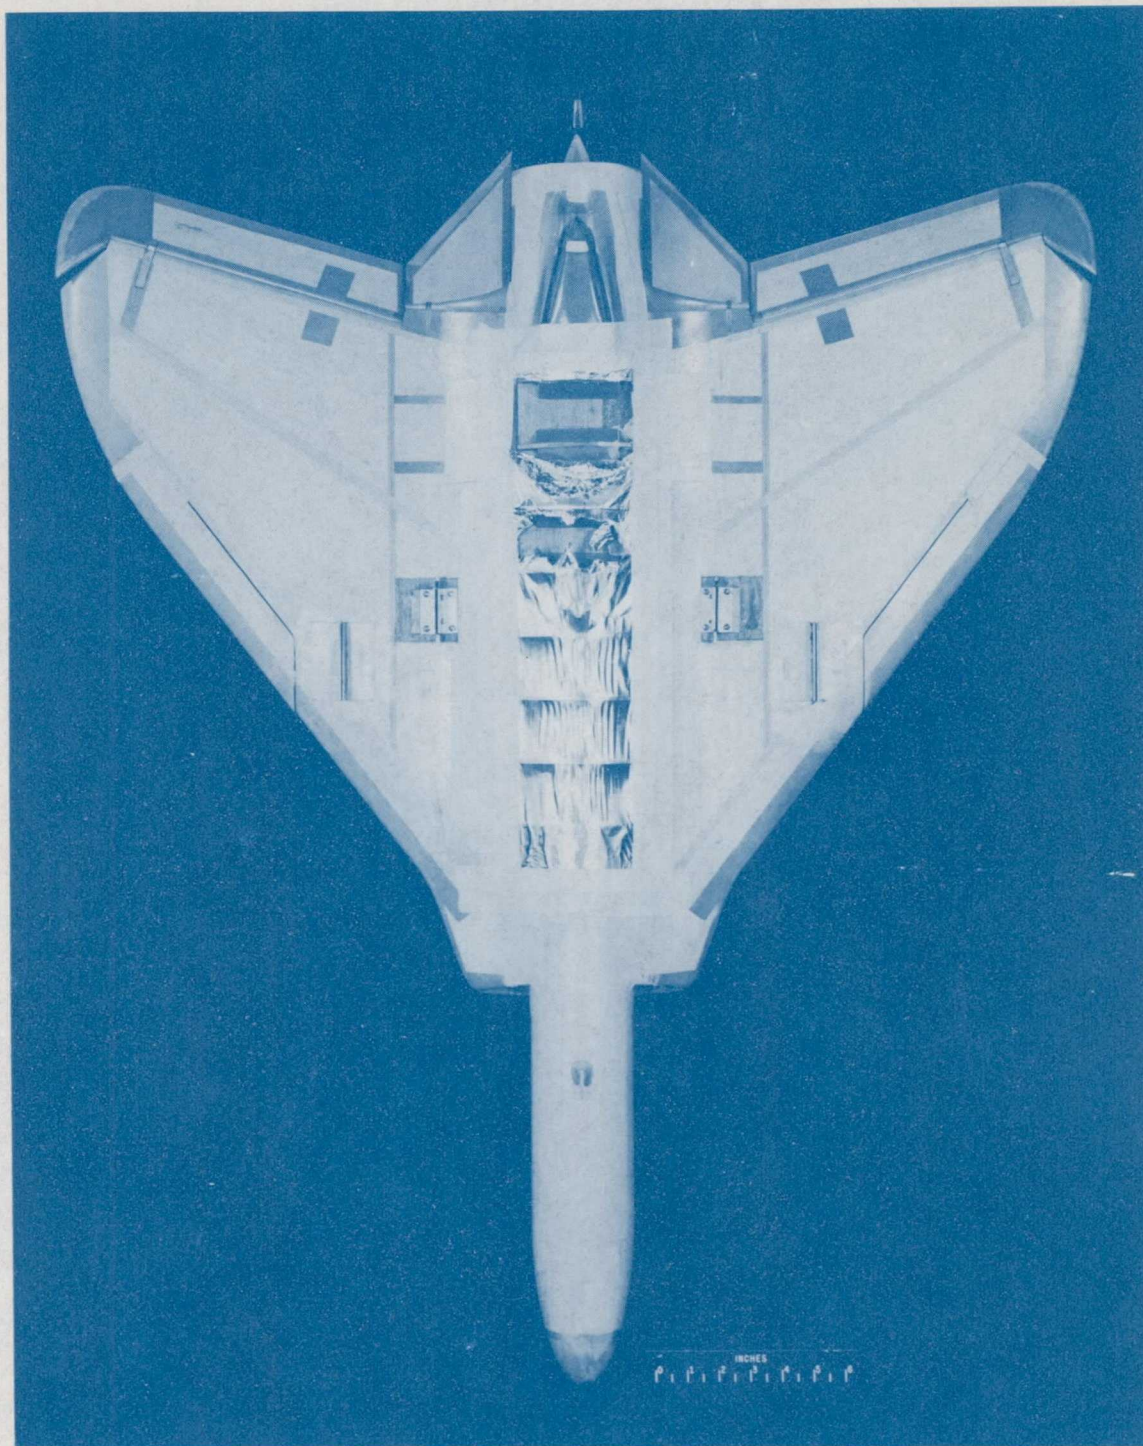
Figure 8.- Typical damage to the aluminum-covered bottom.
